# CASE STUDY:

## MICHELIN US1 PLANT

Michelin Plant in Greenville,  
South Carolina

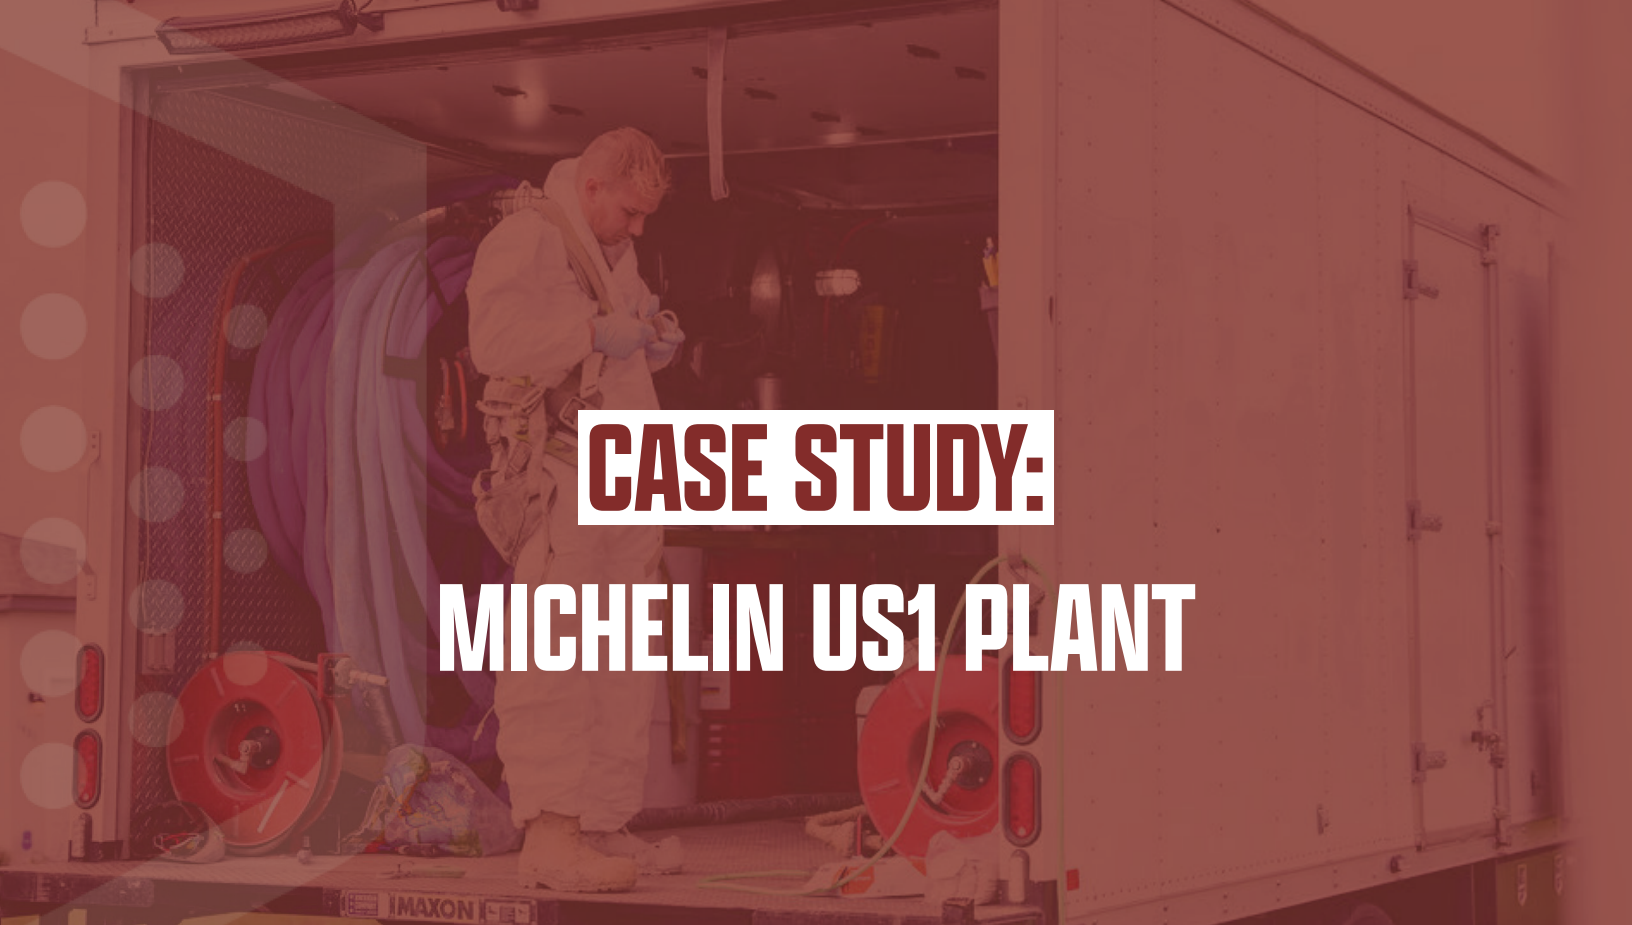
After the existing liner was removed, workers found that due to numerous cracks, water infiltration was much more severe than anticipated.

Our team dealt with this problem by injecting 500 linear feet of floor-to-wall cold joint, and an additional 200 ft. in the wall cracks. This allowed the our Sprayroq crew to begin pressure-washing the structure. It was at this point when it was determined that 8,000 sq. ft. of the wall surface needed to be parged by hand trowel to bring the wall up to spec. After all this preparation was complete, SprayWall® could be applied to the structure, from 150 to 250 mils. thick in some places.
