CASE STUDY:

LAKE HERON OVERFLOW DISCHARGE PIPE

City of Liverpool,
Pennsylvania

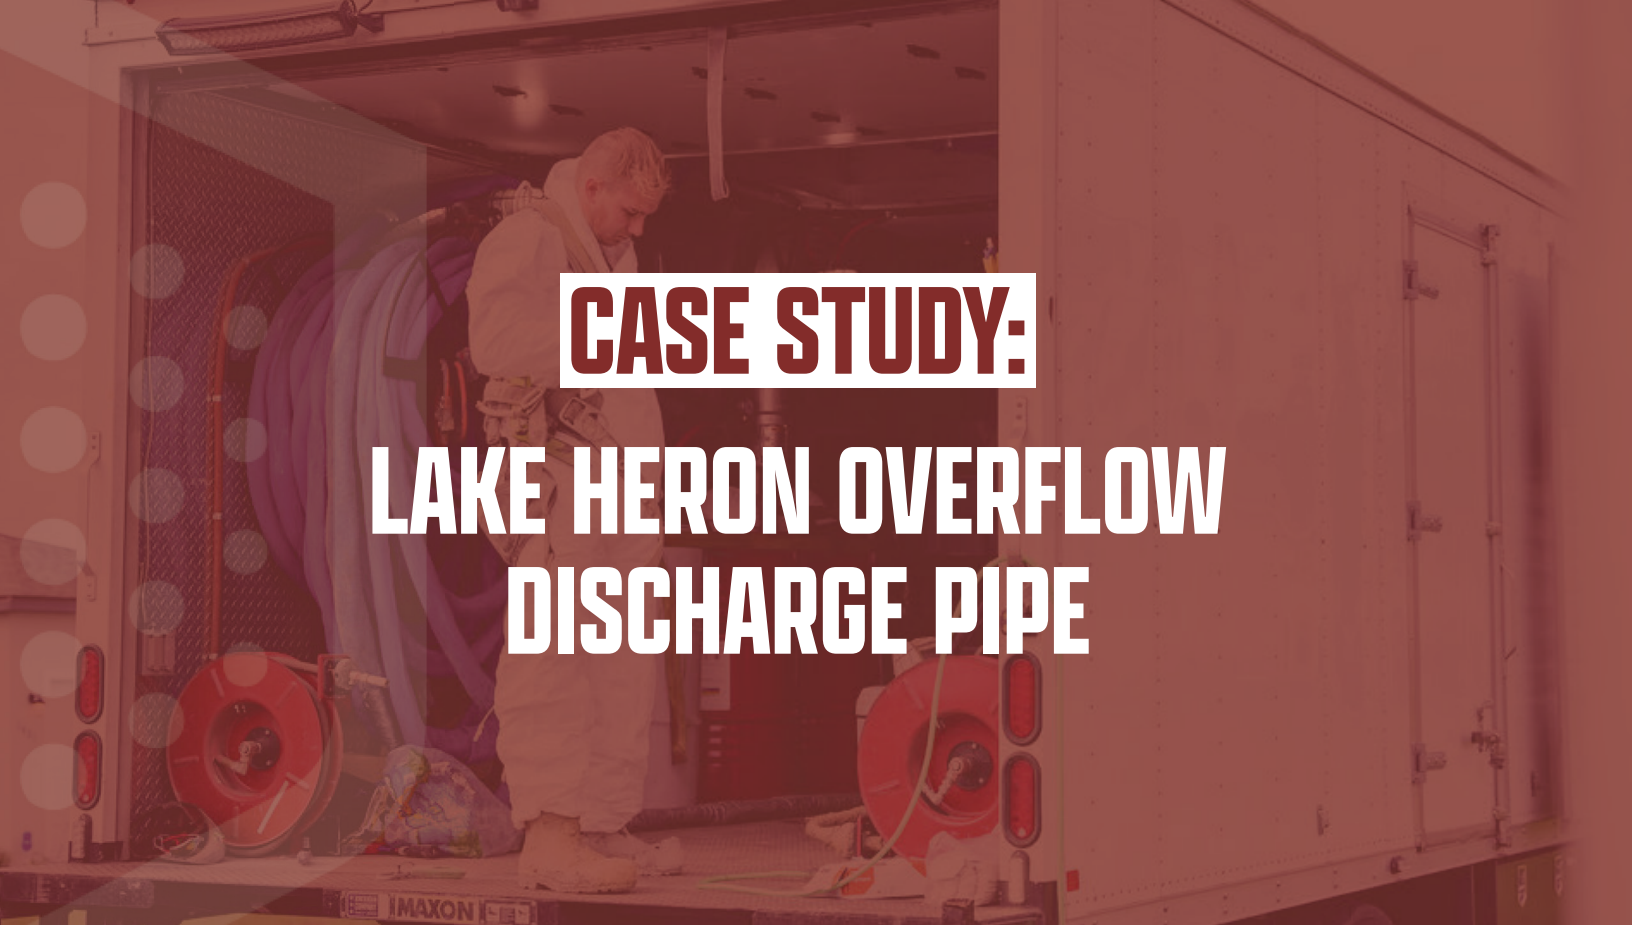
the lake's overflow pipe located on the edge of the lake had deteriorated to the point where many flow points were located along its length.

To fix the pipe, the city needed a corrosion barrier and a product that was structural in nature. The pipe would require 300 ml. of Sprayroq Spraywall to give the structure the corrosion barrier and structural protection it needed.

Two factors not looked on positively in the coatings world are water and weather, and this project involved plenty of both. Water was the primary problem, since the pipe was located in the lake. The water had to be blocked out and dried up before the project could continue. This was achieved by stopping the infiltration with a chemical grout pumped into the openings, then using a blower to dry the structure.

With water and weather issues out of the way, the crew began to prep the structure and get ready to spray. The pipe would require 300 ml. of Sprayroq Spraywall to give the structure the corrosion barrier and structural protection it needed.

The project took two days and used 1100 lbs. of Spraywall material. The city was now able to re-turn the lake to regular recreational use.
