## CASE STUDY:

# SPARTANBURG, SC INFLOW PIPE

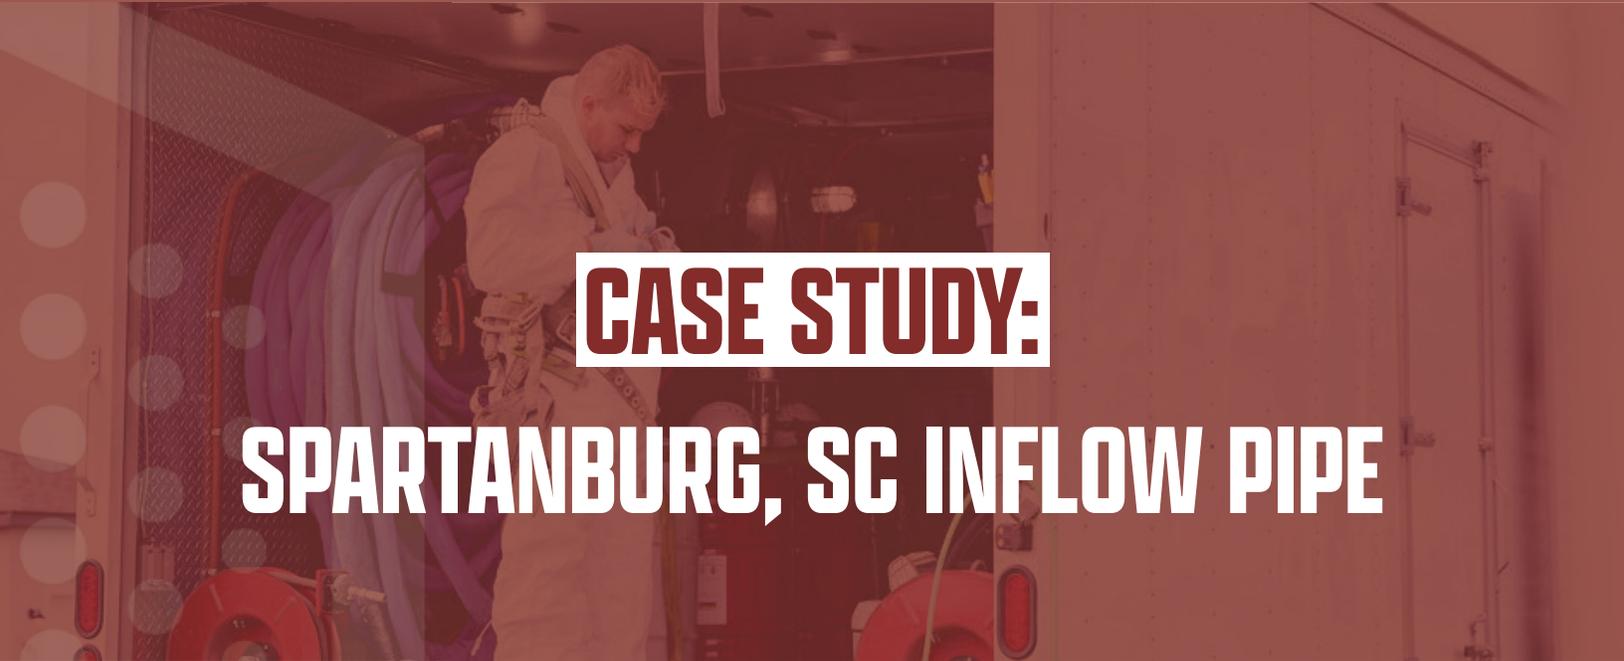
The galvanized corrugated vertical inflow stand pipe on the golf course 6 acre pond was deteriorated badly. The holes in the pipe were significant and caused the pond level to be over 3 feet below normal pond elevation. The pond is located in a upscale golf course community. The residents were very upset to have the water level 3-4 feet below normal.

Our Sprayroq certified applicator proposed the solution of creating a new water tight skin by encapsulating the compromised stand pipe using Spraywall®. The water level was dropped several feet to get below the holes in the standpipe. Our crew mobilized and set up over the weekend without interrupting residents or golfer. On Mondays there is no golf play because of normal maintenance to the golf course. Our team used boats and a specially designed floating work platform to prep, prime and spray apply the new exterior and interior Spraywall® to the standpipe. All work was completed including demobilization in the single day. There was no negative impact to the golf course, the residents, golf play resumed as scheduled on Tuesday morning.

Over time the flow of water from rain and the supply spring brought the pond back up to normal full pond. The “solution” was a complete success.
