# **CASE STUDY:**

# **HOLDING TANK REHABILITATION**

Northern Indiana Utility

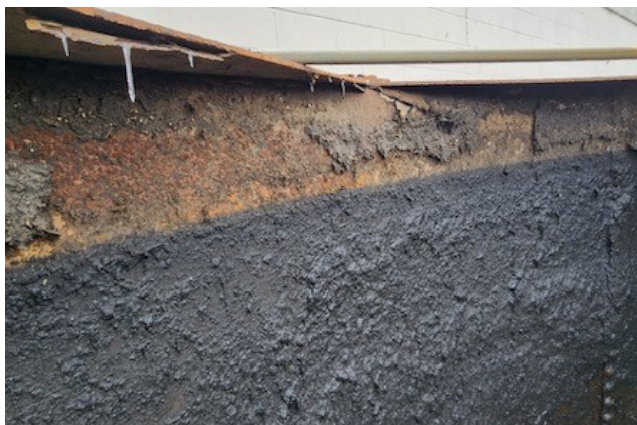
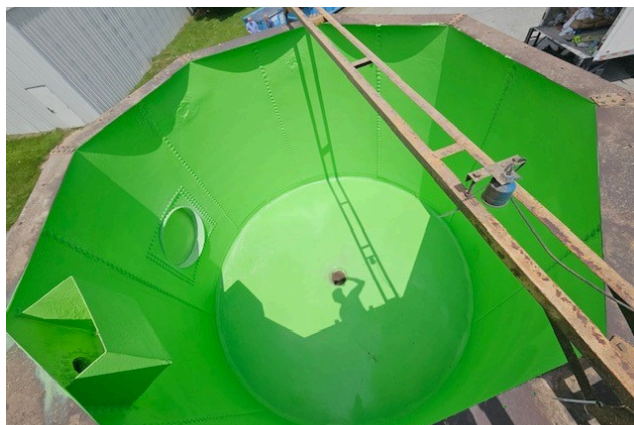
A steel holding tank was suffering from severe deterioration after being exposed to corrosive materials and outdoor environmental conditions.

Upon surface preparation, it was clear that the steel substrate was more severely corroded than anticipated. The deterioration was extensive, so much so that during vapor blasting with crushed glass media, holes were blasted through the steel walls in multiple areas. This necessitated immediate welding repairs, adding complexity to the project. Additionally, the open-top design and above-ground location of the tank meant it was subject to continuous environmental movement and exposure, requiring a flexible and highly robust lining system.

- Surface Preparation: Vapor blasting with crushed glass media was used to remove existing corrosion and prepare the steel surface.
- Structural Smoothing: A fast-set mortar was applied to round the sharp angles at the base of the tank, ensuring a uniform substrate profile.
- Priming: The cleaned surface was primed to optimize adhesion and enhance lining performance.
- Corrosion Lining: Sprayroq's SprayShield Green was selected and applied at an enhanced thickness of 200 mils to offer superior corrosion resistance and flexibility. SprayShield Green's formulation is specifically designed to accommodate above-ground structural movement, making it ideal for the tank's open-air environment.

Despite the setbacks posed by the deteriorated steel, the project was successfully completed with a robust, monolithic lining system now protecting the tank from future corrosion. The SprayShield Green application not only restored the tank's operational integrity but also provided long-term durability in one of the facility's most aggressive environments. Thanks to the expertise of Conco Spray Solutions and the high-performance properties of SprayShield Green, the utility can expect reliable service from this rehabilitated asset for years to come.
