## CASE STUDY:

# PERRY POINT, MD

MD Medical Center

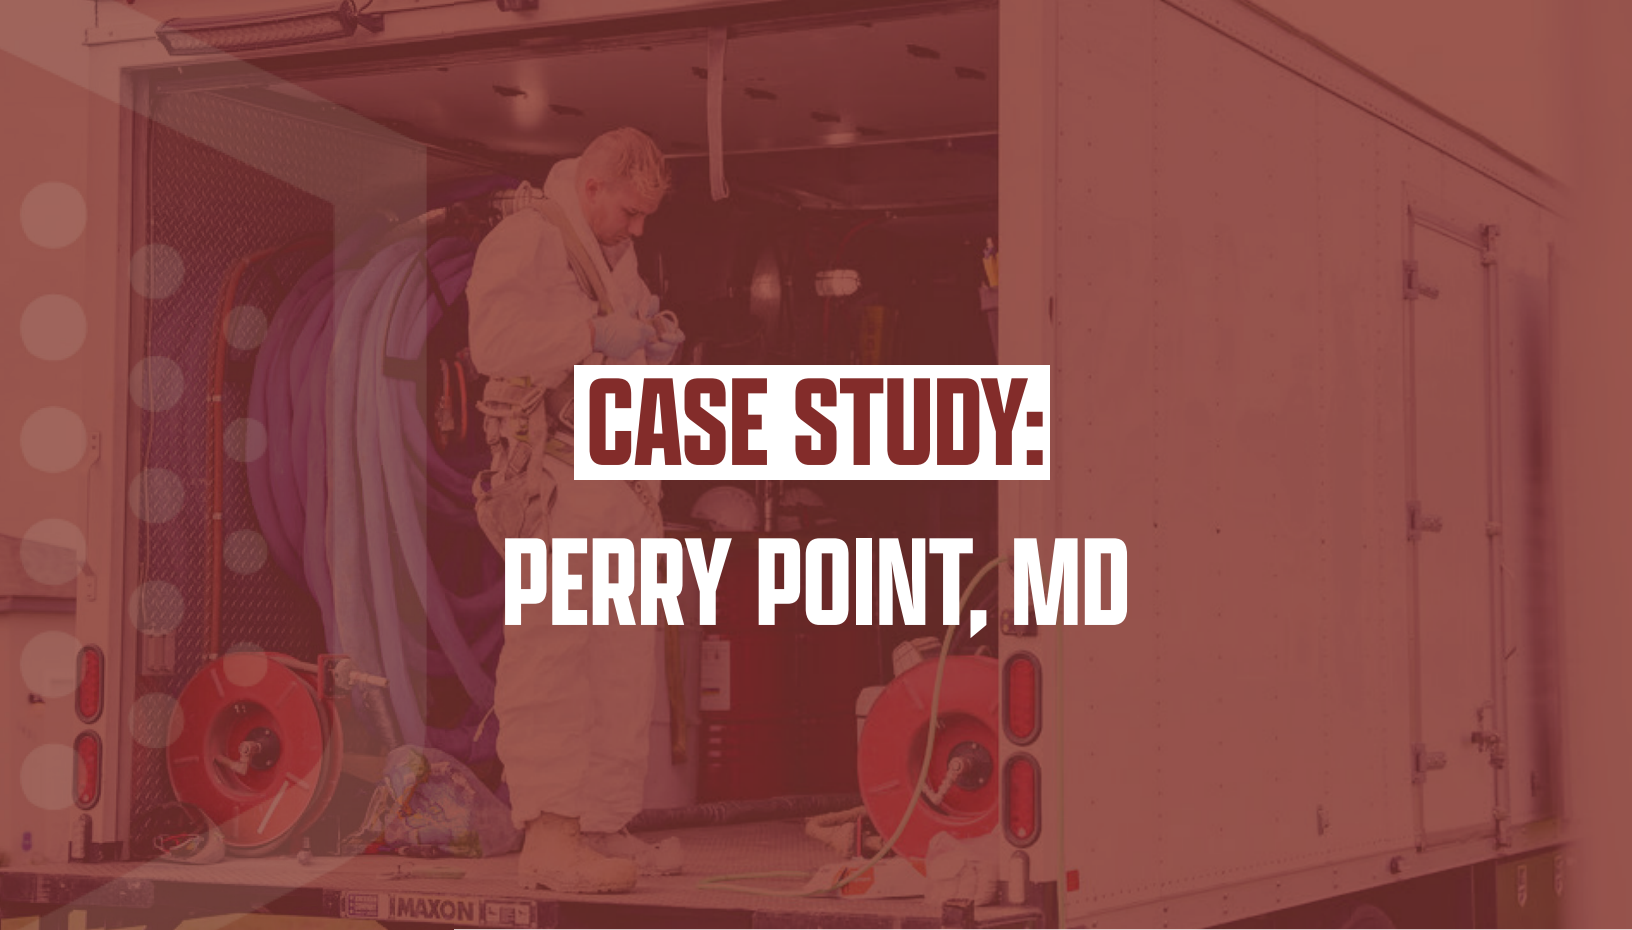
Fresh water is pumped directly from the Susquehanna River into two 16'W x 60' L x 15' High concrete sedimentation settling tanks. These 70-year-old flat wall concrete tanks were showing signs of deterioration as exposed aggregates and bug holes.

Spray Shield Green<sup>1</sup> lining was applied to eliminate future deterioration of the concrete walls and improve the tanks' sediment cleaning operations.

200 mils of Spray Shield Green1 lining was applied to eliminate future deterioration of the concrete walls and improve the tanks' sediment cleaning operations.
