CASE STUDY:

COLORADO MANHOLE REHABILITATION

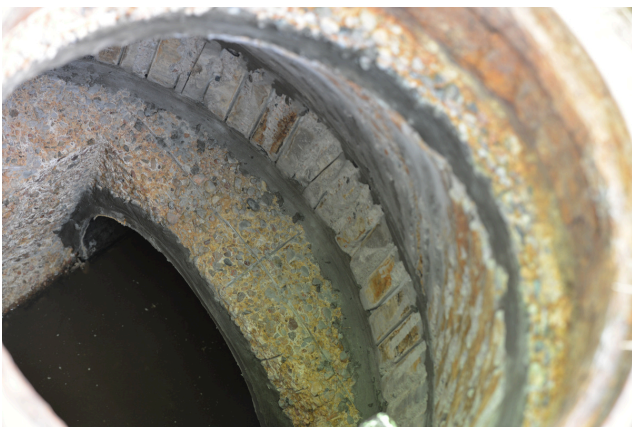
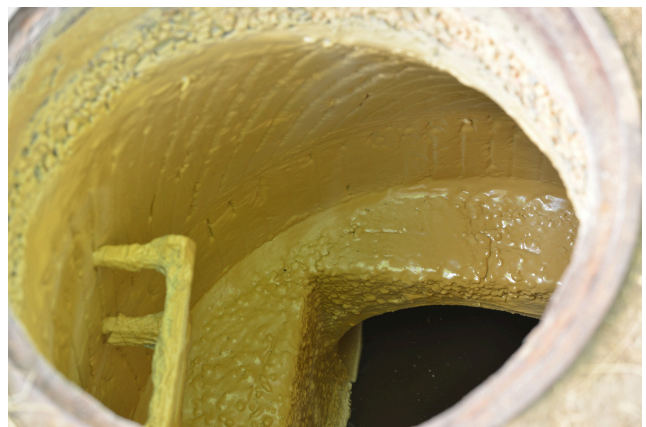
A local municipality faced significant inflow and infiltration issues and concrete deterioration within a series of aging manholes across their sewer district.

Over time, previous lining systems in the manholes had failed, allowing infiltration and deterioration to compromise structural stability. Traditional dig-and-replace rehabilitation was considered, but this approach would require extensive excavation, high costs, prolonged timelines, and significant disruption to residents and businesses.

The project was awarded to QP Services, a trusted Sprayroq Certified Partner, through a competitive bid process. Backed by more than a decade of successful work with Sprayroq products for this municipality, QP Services had established a strong reputation for reliability, consistent quality, and the ability to deliver on complex rehabilitation projects. Key steps included removing failed liner materials, repairing infiltration points, and applying 250 mils of SprayWall, Sprayroq's high-strength structural polyurethane lining system, to each manhole.
